FINAL
FOUNDATION
REPORT

COMPLETION OF EMBANKMENT
OUTLET WORKS AND SPILLWAY
COOPER LAKE
SULPHUR RIVER, TEXAS

CORPS OF ENGINEERS
FORT WORTH DISTRICT, TEXAS

MAY 1992

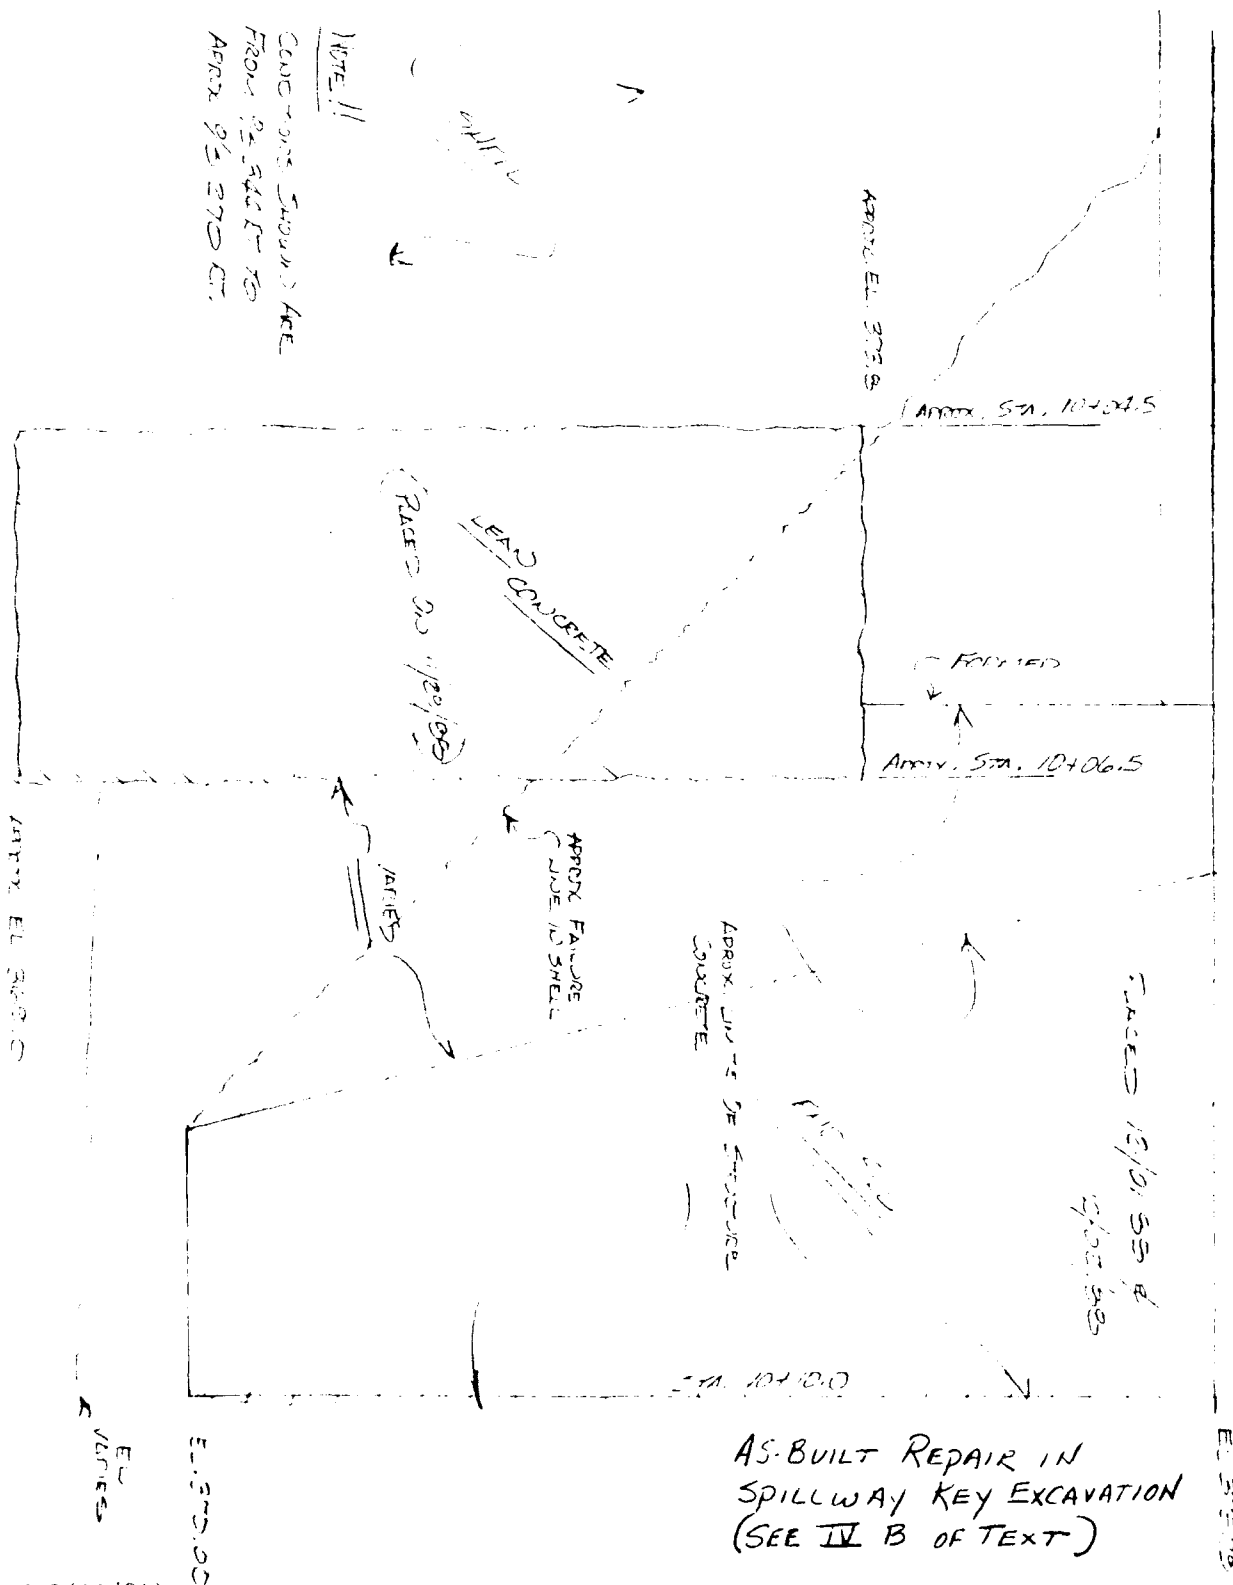
B. Unanticipated Foundation Conditions Encountered During Construction. The cutoff key beneath the end sill at the downstream end of the spillway slab was first excavated from offset 344 feet right to offset 294 feet right (50 feet) on 25 October 1988. The upstream slope of the key was cut first using a self-propelled Vermeer T-650 ditching machine (effectively a saw). The upstream slope of the key is inclined downstream at the rate of 4 feet vertical on 1 foot horizontal. This cut was approximately 5.5 feet deep and its width was approximately that of the cutter head. Large splinter-shaped pieces of shale slid out of the upstream slope into and across the cut before the intended full length of the first cut was completed. The vertical downstream face of the key was then cut and the slide blocks were removed from the key excavation. The upstream slope of the key was then laid back to a slope of 1 foot vertical on 1 foot horizontal, which was the approximate dip of the planes on which the blocks of shale had slid downstream. The shale was then sprayed with Aerospray 70 to protect it from drying. Very shortly after this a number of large but thin (3 inches thick?) sheets or slices of shale slid out of the upstream slope of the key, crossing the key excavation. The key excavation was then refilled with a temporary backfill of shale rubble because of imminent rain showers. The slide planes on which the shale moved were poorly slickensided fractures dipping downstream at an inclination of roughly 45°. The foundation shale in this portion of the spillway appeared to have a poorly developed cleavage dipping in the same direction and to the same degree as the slide planes. The key foundation was not reopened and repaired until 1 December 1988. Figure 1 shows the

method of repair utilized by the contractor. No further slides or problems of this sort were experienced in the remaining excavation of the key or other foundation excavations.

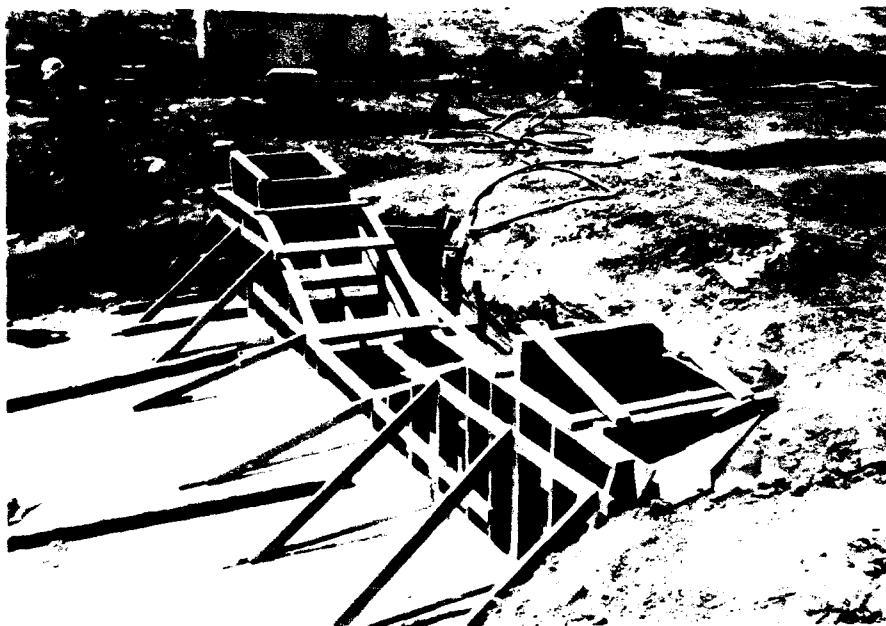
FIGURE 4. Forming for collar structural concrete after build up of backfill concrete beneath collar forming. Downstream is to right.

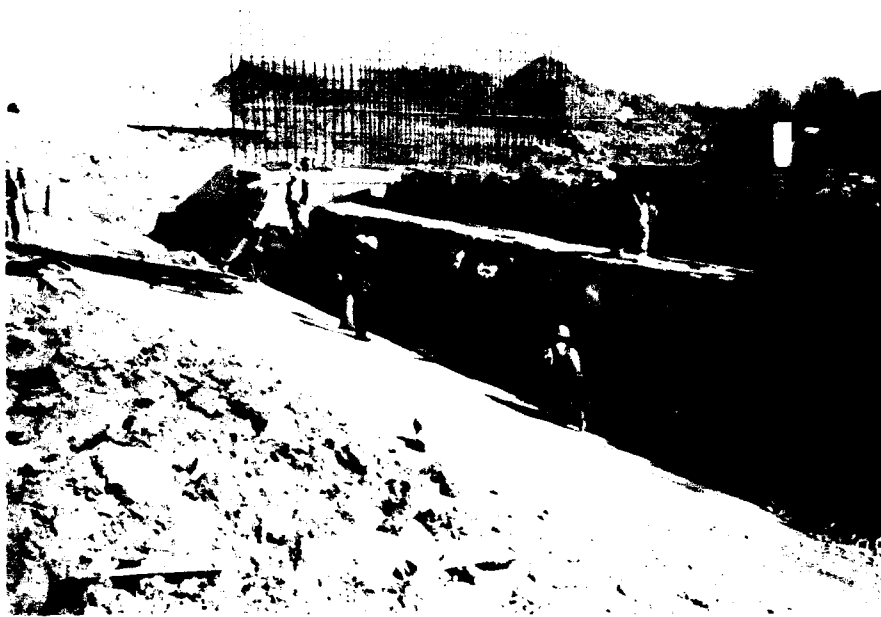
FIGURE 10. Looking right and upstream. Spillway weir foundation with right wall footing (R-6) in background. Note limestone in backslope (upstream) overlain by re-compacted clay and underlain by undisturbed fine sand.

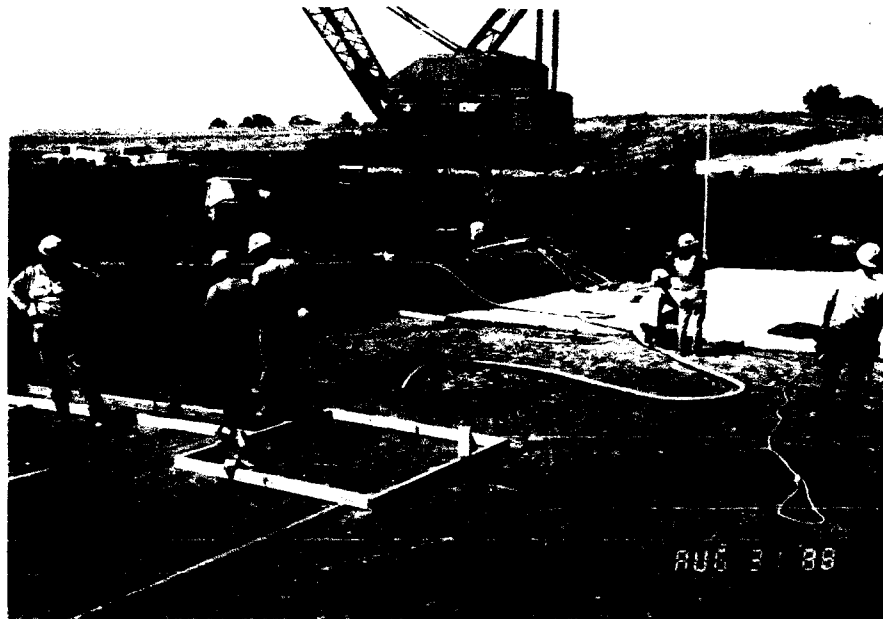
FIGURE 24. Foundation of spillway wall footing R-14. R-15 is covered by protective concrete. Note: Board angle seen here is not that of previous photos. Previous form board angle is beyond stacked shovels on concrete in this Photo.
